FACILITY COMPLIANCE INSPECTION REPORT

Division of Waste Management Solid Waste Section

Date of Site Inspection: August 23, 2013 **Date of Last Inspection:** April 10, 2013

Lowder Sandrock LCID Landfill
5860 Sandrock Drive
Burlington, NC 27217

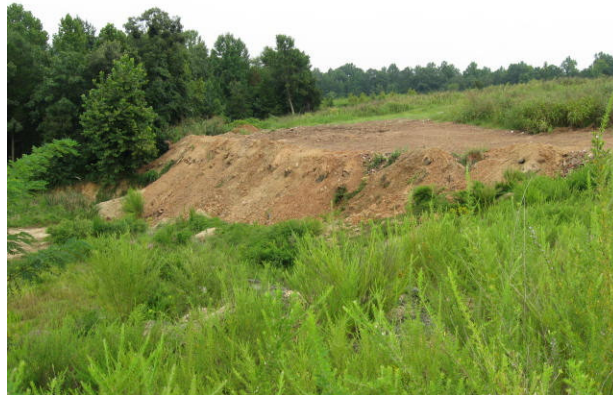
7. The LCID landfill is covered with soil.
8. Side slopes appeared to be graded accordingly.
9. Ensure that the side slopes are graded such that no indication of erosion or runoff is observed.

Landfill area and side slope

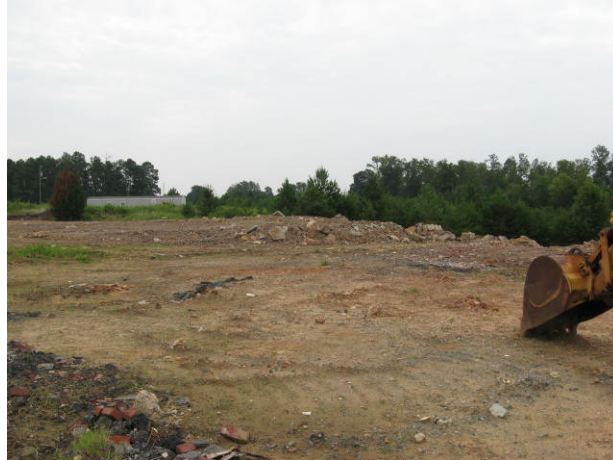
10. Ensure vegetative ground cover is established.
11. Inert debris (rock, brick, and concrete) is being used for beneficial fill. Mr. Bryant is in the process of grading and covering the material with soil.

Beneficial fill area – to be graded and covered with soil

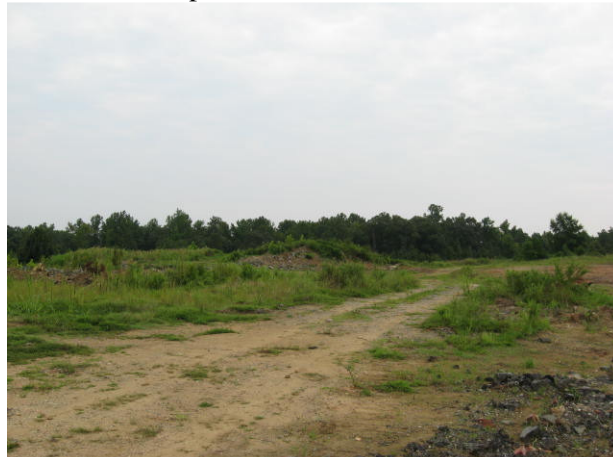
12. Mr. Bryant stated that used asphalt stored on site will be used as roadbed material.
13. The facility is secured by a locked gate at the entrance to the property.

Pile of used asphalt to be used as roadbed material
